Industrial roof portfolio

Successful roof facility management – Georgsmarienhütte example

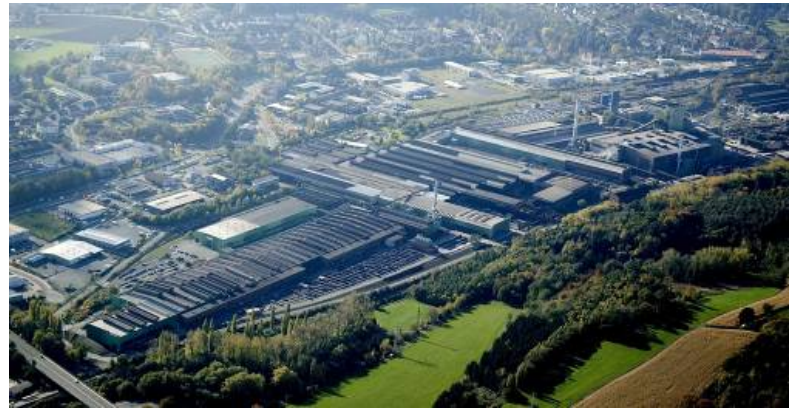
perts from VEDAG several things to think about. The analysis showed highly varying layer depths across the 12000m² roof surface, for example, while the waterproofing was also heavily encrusted with dirt in some cases. In addition to this, water penetration damage was found in many areas and had already affected the supporting shell. The two old layers, with bitumen adhesion, were also bonded very strongly together and to the roof. The results of the analysis were unequivocal - mechanical removal of the old roof would require a great deal of work if the framework was not to be destroyed.

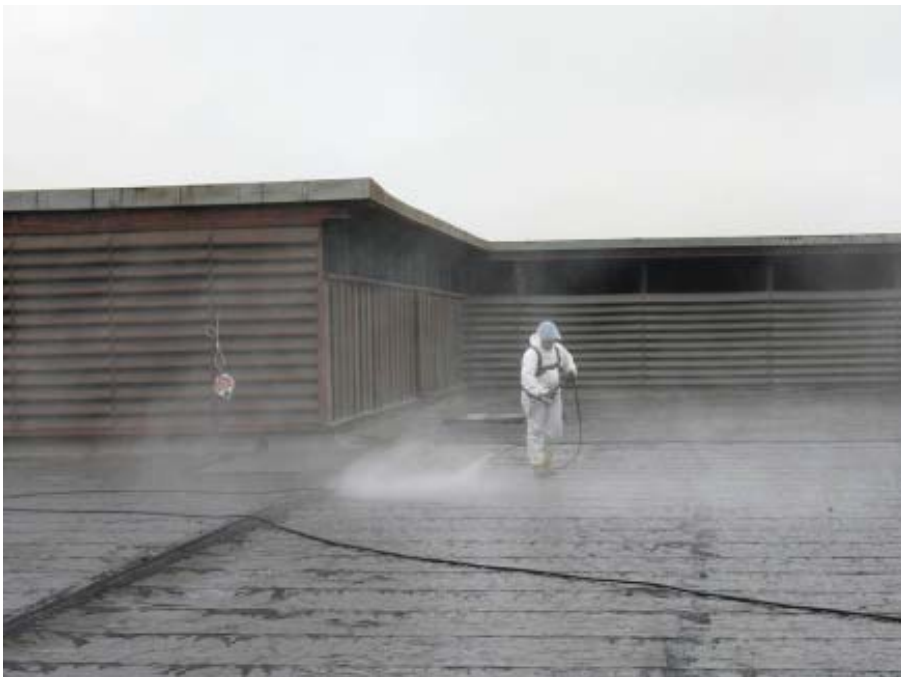
The heavily encrusted old roof had to be intensively cleaned beforehand.

winter of 2009/2010, the first section was finally tackled in summer 2010. The entire roof surface first had to be cleared of heavy encrustations using a special high-pressure cleaner. The experts replaced particularly badly damaged perforated brick cover sections with trapezoidal steel plates. A special solution (Emaillit BV schnell) characterised by its quick drying time and improved dust binding quality was used as the primer.

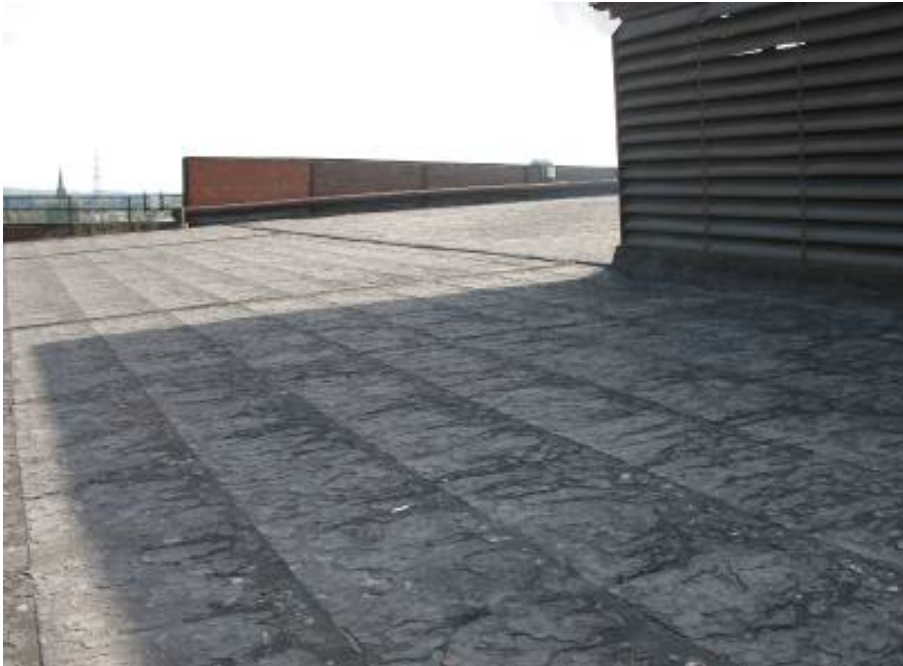
*The poor condition of the roof of the Georgsmarienhütte before the revitalisation. **Source:** VEDAG GmbH*

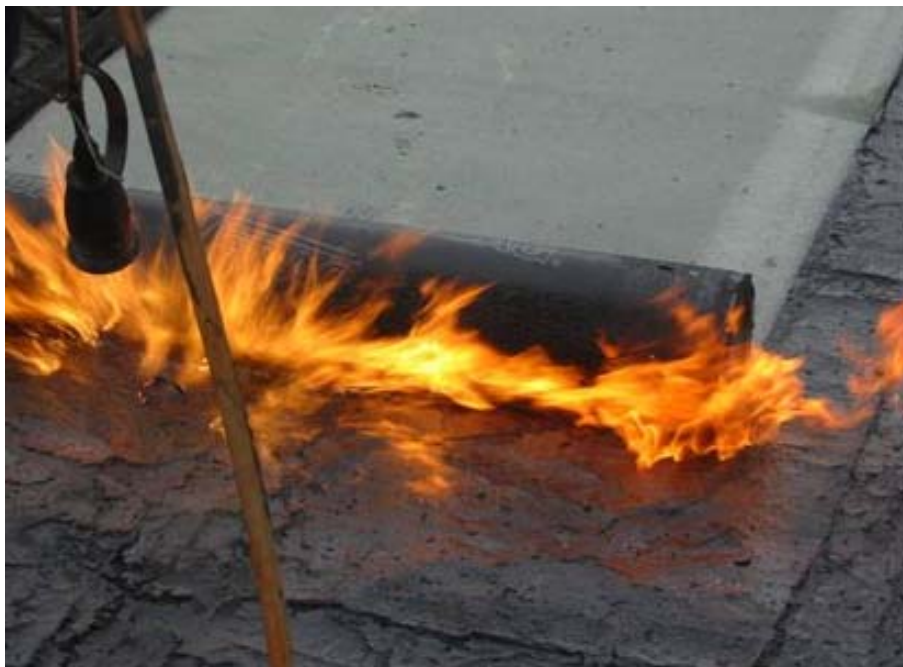
*The first layer (VEDAFLEX G4E) is applied to the prepared surface. **Source:** VEDAG GmbH*

cleaned waterproofing layer. Therefore, tests were performed with differently modified sheeting from the area of waterproof polymer sheeting. Ultimately, an elastomeric bitumen waterproof sheeting (VEDAFLEX G4E) achieved the best on-site results. VEDAG and GMH included a roofing contractor in the planning at this early stage also - local company Salzer & Piepmeyer was asked to assess how the material could be processed with reference to the joints, connection points and roof structures. Further laboratory tests, which also included the simulated, accelerated ageing of the sheeting, confirmed that the right material had been chosen. "However, it was crucial for us that VEDAG was prepared on the basis of the laboratory results to grant a 15-year guarantee for the new waterproofing", emphasised Karsten Jung, planner and engineer at GMH.

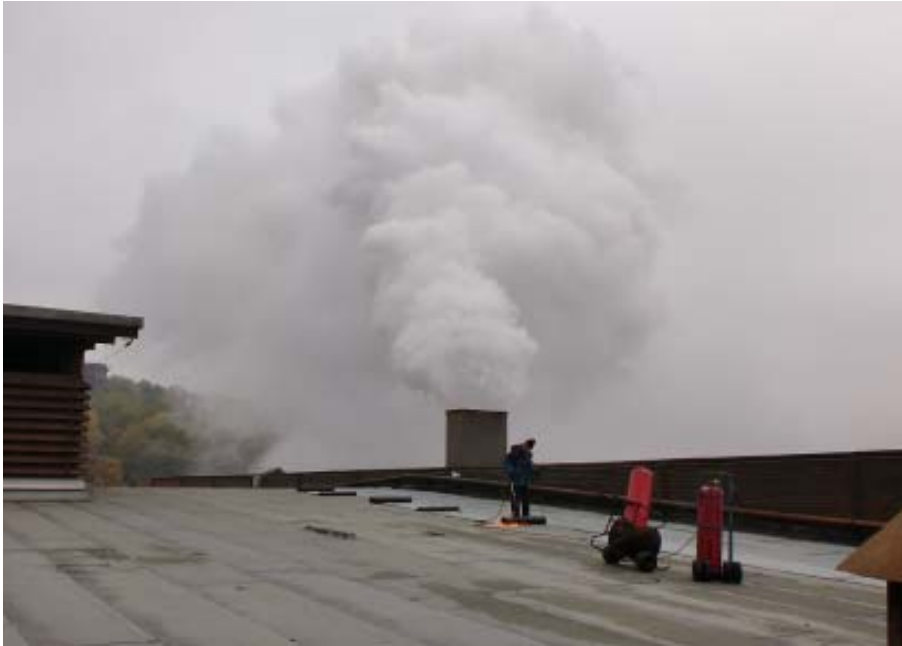
*The VEDATOP DUO dolomite grey Broof(t3) top layer is welded on during normal production in the steelworks. **Source:** VEDAG GmbH*

Unlike waterproofing for a new building, the homogenous, all-over compound welding in roof renovations necessitates special burner control. The specialists in VEDAG application technology helped support the roofing contractor on site with this. The second top sheeting was only applied once the first waterproofing layer had been completely welded to the existing material. A special polymeric bituminous waterproof sheeting (VEDATOP DUO (t3) dolomite grey) which ensures particularly high-grade water-proofing both in relation to increased fire protection in accordance with DIN V ENV 1187 and long-term coating behaviour was used for this.

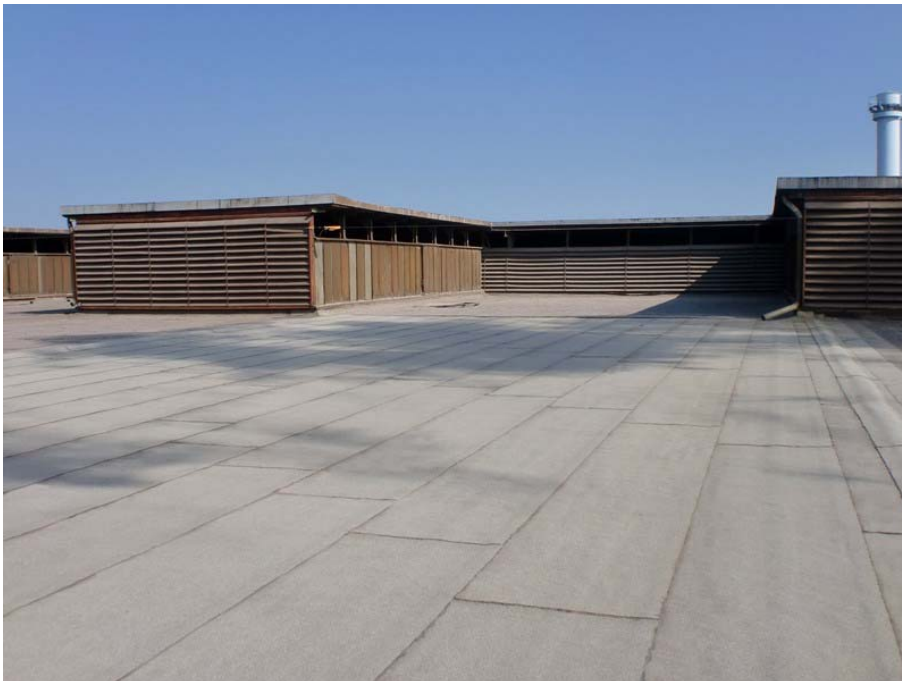
*Endurance test passed: the test roof surface after six months. **Source:** VEDAG GmbH*

Roofing contractor Salzer & Piepmeyer laid an initial 1000m² test surface in autumn 2009. After a favourable wait time over the long and cold

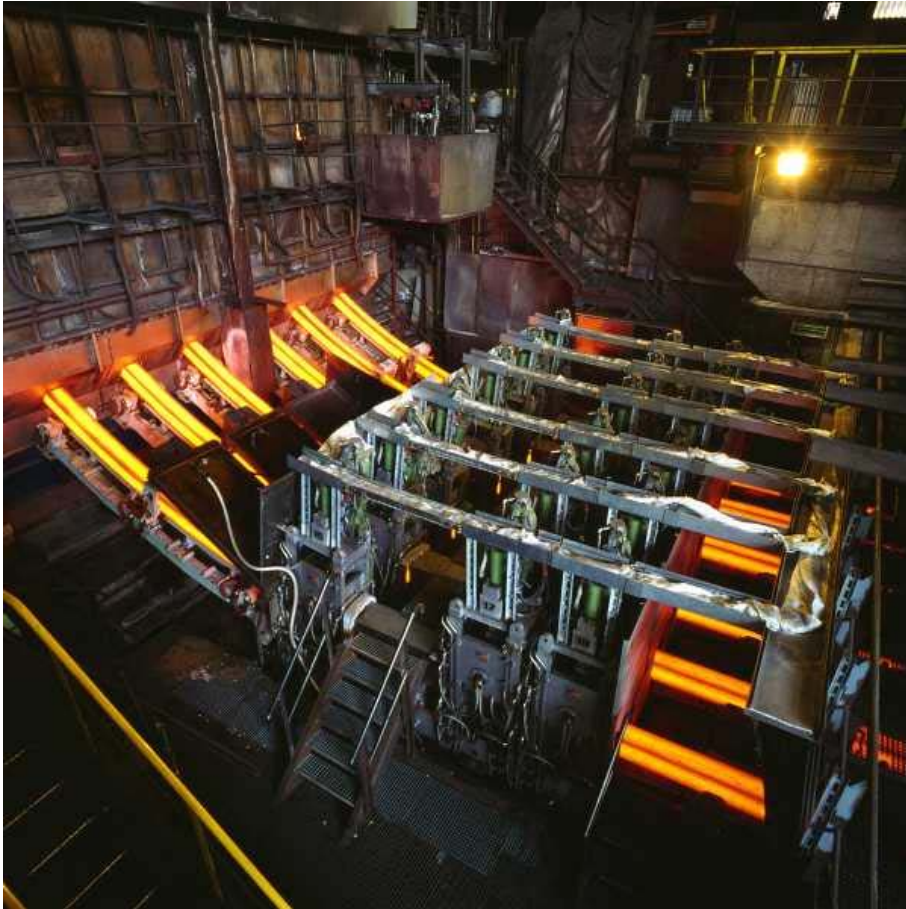
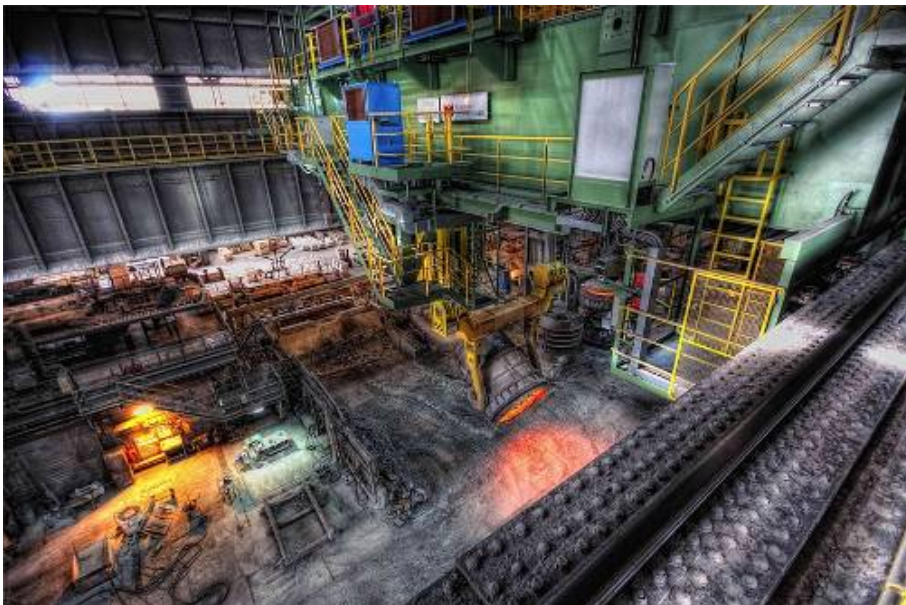
*Steel production continued under the roof while the complex revitalisation work was ongoing. **Source:** Georgsmarienhütte GmbH*
